**Flood Control Project Maintenance  
Levee Inspections**

## Maintenance Issue Types Only, Levee Inspection Report By Mile - Spring 2017

### Reclamation District No. 1001 Nicolaus

Waterway	Bank	Unit Miles	Inspection Start/End	Inspector
Unit No. 01 Yankee Slough	Right	4.12	03/28/2017 03/28/2017	Sterling York

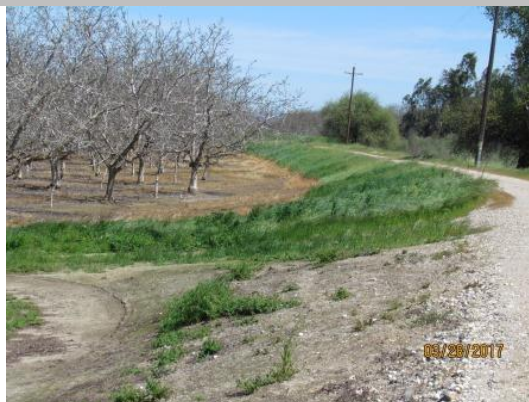
Photo 1 of 1 : SP\_2017\_RD1001\_36\_24\_20170403\_00027.jpg

LM Start	0.14	Rating **	M	Issue No.	24
LM End	1.52	Issue Type +	Ma	Location *	LS
Category	Earthen Levee			GPS Latitude/Longitude	
				Start	End
Item	Vegetation			38.978880 °	38.970688 °
				-121.471989 °	-121.494025 °
DWR ID	DWR_RD1001_01_s_2017_24				
Comment Code					
V1 : Control annual grass and weeds on the levee slopes and easements.					
Inspector Comment					
Maintain annual vegetation, Spring 2017,

View of annual vegetation looking upstream, landside. Spring 2017.

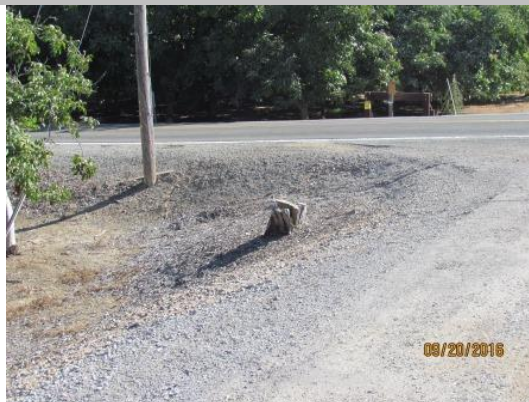
Photo 1 of 1 : SP\_2017\_RD1001\_36\_10\_20170316\_00008.jpg

LM Start	2.75	Rating **	N	Issue No.	10
LM End	2.75	Issue Type +	Ma	Location *	LS
Category	Earthen Levee			GPS Latitude/Longitude	
				Start	End
Item	Trim / Thin Trees			38.968376 °	38.968376 °
				-121.515626 °	-121.515626 °
DWR ID	DWR_RD1001_01_f_2015_10				
Comment Code					
T5 : Tree stumps.					
Inspector Comment					
Remove tree stump from lvee slope. Spring 2017.

View of stump on the landside slope looking upstream. Fall 2016.

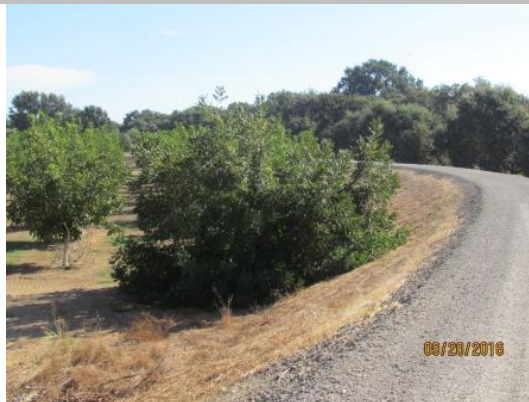
Photo 1 of 1 : SP\_2017\_RD1001\_36\_19\_20170316\_00015.jpg

LM Start	3.09	Rating **	M	Issue No.	19
LM End	3.09	Issue Type +	Ma	Location *	LS
Category	Earthen Levee			GPS Latitude/Longitude	
				Start	End
Item	Trim / Thin Trees			38.965660 °	38.965660 °
				-121.520548 °	-121.520548 °
DWR ID	DWR_RD1001_01_s_2016_19				
Comment Code					
T1 : Trim trees to at least five feet above ground level.					
Inspector Comment

View of a tree that need limbs trimmed. Fall 2016.

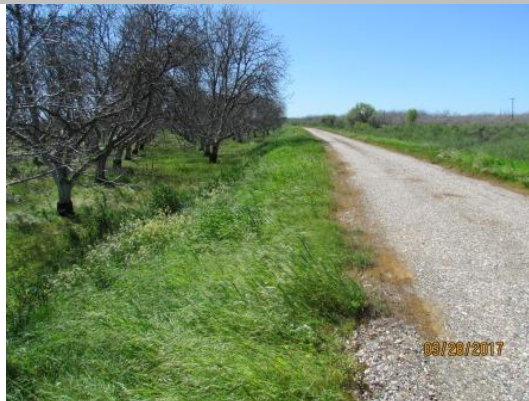
Photo 1 of 1 : SP\_2017\_RD1001\_35\_8\_20170403\_00027.jpg

LM Start	0.00	Rating **	U	Issue No.	8
LM End	3.64	Issue Type +	Ma	Location *	LS
Category	Earthen Levee			GPS Latitude/Longitude	
				Start	End
Item	Vegetation			38.971202 °	38.965845 °
				-121.473999 °	-121.533658 °
DWR ID	DWR_RD1001_02_s_2017_8				
Comment Code					
V1 : Control annual grass and weeds on the levee slopes and easements.					
Inspector Comment					
Maintain annual vegetation, Spring 2017.

View looking downstream of annual vegetation, Spring 2017.

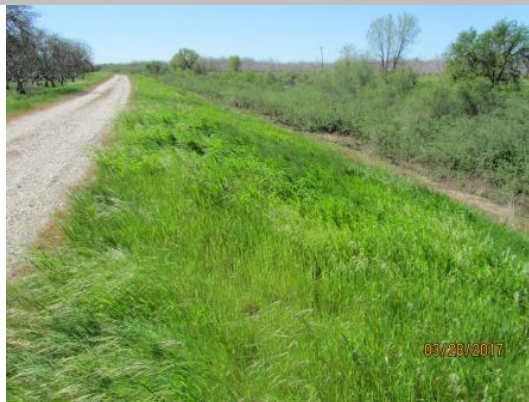
Photo 1 of 1 : SP\_2017\_RD1001\_35\_9\_20170403\_00028.jpg

LM Start	0.00	Rating **	U	Issue No.	9
LM End	3.64	Issue Type +	Ma	Location *	WS
Category	Earthen Levee			GPS Latitude/Longitude	
				Start	End
Item	Vegetation			38.971219 °	38.965845 °
				-121.474038 °	-121.533658 °
DWR ID	DWR_RD1001_02_s_2017_9				
Comment Code					
V1 : Control annual grass and weeds on the levee slopes and easements.					
Inspector Comment					
Maintain annual vegetation, Spring 2017.

View looking downstream of annual vegetation, Spring 2017.

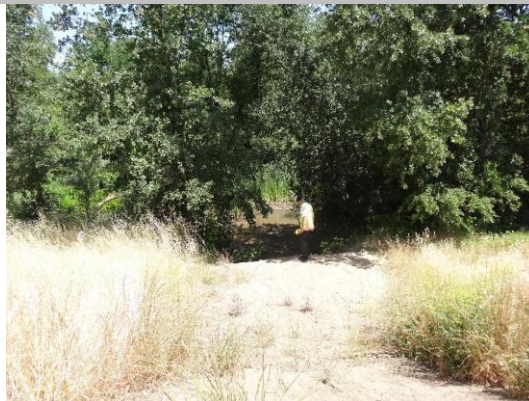
Photo 1 of 3 : UCIP\_SP\_2017\_14008\_23108.jpg

LM Start	2.28	Rating **	M	Issue No.	55
LM End	2.28	Issue Type +	Ma	Location *	LS
Category	Supplemental			GPS Latitude/Longitude	
				Start	End
Item	DWR UCIP LMA Responsibility			38.967403 °	38.967403 °
				-121.510953 °	-121.510953 °
DWR ID					
Comment Code					
Inspector Comment					
FS_ID:14008					
DS_ID:22543					
EP_NO: N/A					
Repair Type: Non-Urgent					
Crossing Status: Found					
UCIP Comments: - slide gate in inlet pipe on landside - pits on pipe due to corrosion					
FIELD_STRUCT_DESC: 36-inch corrugated-metal drainage pipe through the levee, 15.0 feet below the crown, concrete-U headwall and flap gate at outfall on the waterward end and slide gate on landside inlet (R.D. No. 1001). O&M Manual Sac 141, August 1955.					
FS Date: 5/23/2013

WS- overview of waterside of the levee.

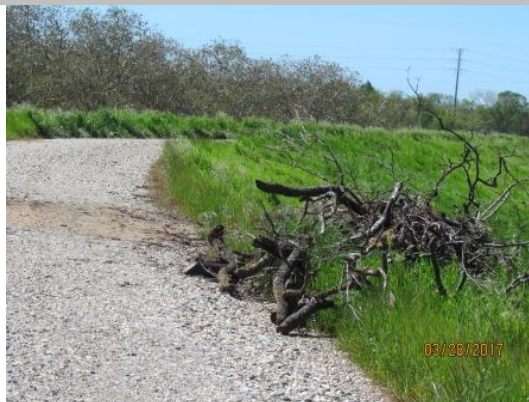
Photo 1 of 1 : SP\_2017\_RD1001\_35\_27\_20170403\_00035.jpg

LM Start	3.25	Rating **	M	Issue No.	27
LM End	3.25	Issue Type +	Ma	Location *	WS
Category	Earthen Levee			GPS Latitude/Longitude	
				Start	End
Item	Encroachments			38.963728 °	38.963728 °
				-121.526859 °	-121.526859 °
DWR ID	DWR_RD1001_02_s_2017_27				
Comment Code					
PR : Prunings					
Inspector Comment					
Remove prunings from levees hinge point, Spring 2017.

View looking downstream of pruning's on levee hinge point, Spring 2017.

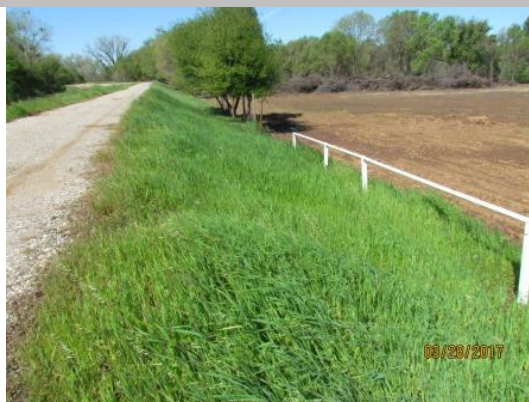
Photo 1 of 1 : SP\_2017\_RD1001\_37\_15\_20170403\_00044.jpg

LM Start	0.01	Rating **	M	Issue No.	15
LM End	12.56	Issue Type +	Ma	Location *	WS
Category	Earthen Levee			GPS Latitude/Longitude	
				Start	End
Item	Vegetation			39.006586 °	38.941259 °
				-121.375118 °	-121.567535 °
DWR ID	DWR_RD1001_03_s_2017_15				
Comment Code					
V1 : Control annual grass and weeds on the levee slopes and easements.					
Inspector Comment					
Maintain annual vegetation. Spring 2017.

View looking downstream of annual vegetation. Spring 2017.

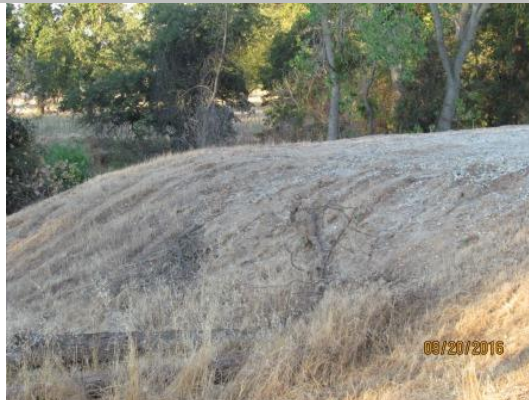
Photo 2 of 2 : SP\_2017\_RD1001\_37\_2\_20170316\_00003.jpg

LM Start	0.11	Rating **	M	Issue No.	2
LM End	0.11	Issue Type +	Ma	Location *	CR
Category	Earthen Levee			GPS Latitude/Longitude	
				Start	End
Item	Slope Stability			39.006569 °	39.006569 °
				-121.377037 °	-121.377037 °
DWR ID	DWR_RD1001_03_f_2013_2				
Comment Code					
S3 : Repair the levee slope damaged by vehicle traffic and prevent access where possible.					
Inspector Comment					
Rutting caused by vehicles driving up the landward levee slope.

View of the same rutting on the landside of the levee facing downstream. Fall 2016.

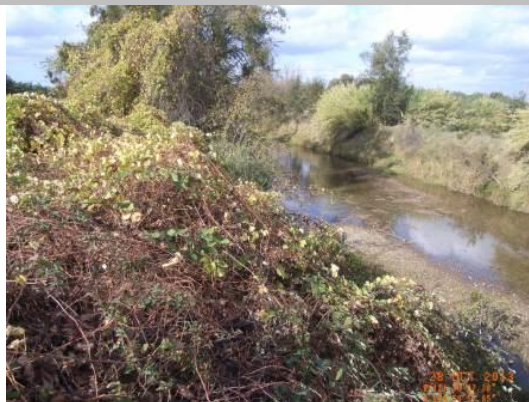
Photo 1 of 1 : SP\_2017\_RD1001\_37\_17\_20170316\_00013.jpg

LM Start	7.22	Rating **	M	Issue No.	17
LM End	7.31	Issue Type +	Ma	Location *	WS
Category	Supplemental			GPS Latitude/Longitude	
				Start	End
Item	2015 USACE Erosion Survey, DRAFT			38.982737 °	38.982572 °
				-121.501144 °	-121.502797 °
DWR ID	DWR_RD1001_03_s_2016_17				
Comment Code					
Inspector Comment					
2008 - Sandy/silty banks with rotational slab failures creating near vertical bank with pop-outs due to tree failures. Narrow berm. 2015: Last observed in 2013. [2015 Site ID: BER_5-7_L]

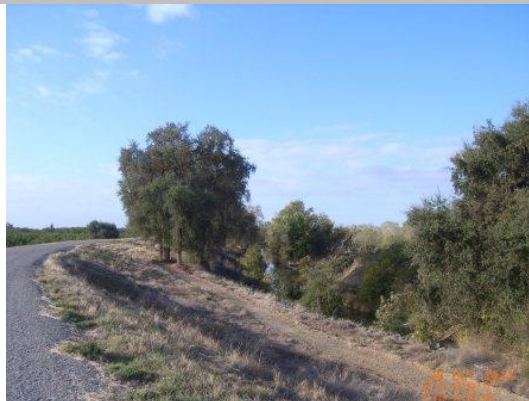
Photo 1 of 1 : SP\_2017\_RD1001\_37\_1\_20170316\_00001.jpg

LM Start	11.08	Rating **	M	Issue No.	1
LM End	11.16	Issue Type +	Ma	Location *	WS
Category	Supplemental			GPS Latitude/Longitude	
				Start	End
Item	2015 USACE Erosion Survey, DRAFT			38.955070 °	38.954227 °
				-121.549528 °	-121.550592 °
DWR ID	DWR_RD1001_03_s_2016_1				
Comment Code					
Inspector Comment					
2011 - Large slumped sections of bank. 2012 - Slopes slightly steeper. 2015: Last observed in 2013. [2015 Site ID: BER_1-9_L]

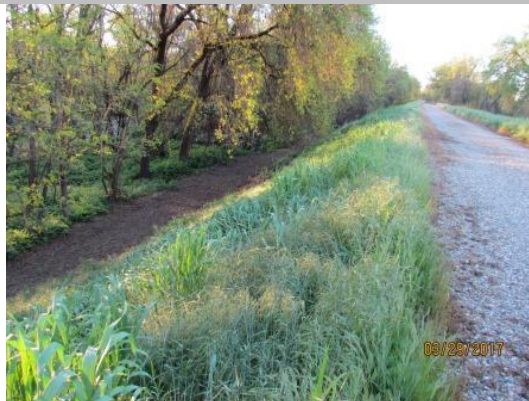
Photo 1 of 1 : SP\_2017\_RD1001\_38\_35\_20170403\_00066.jpg

LM Start	0.01	Rating **	M	Issue No.	35
LM End	2.50	Issue Type +	Ma	Location *	LS
Category	Earthen Levee			GPS Latitude/Longitude	
				Start	End
Item	Vegetation			38.940892 °	38.906724 °
				-121.567674 °	-121.576035 °
DWR ID	DWR_RD1001_04_s_2017_35				
Comment Code					
V1 : Control annual grass and weeds on the levee slopes and easements.					
Inspector Comment					
Maintain annual vegetation, Spring 2017.

View looking downstream of annual vegetation, Spring 2017.

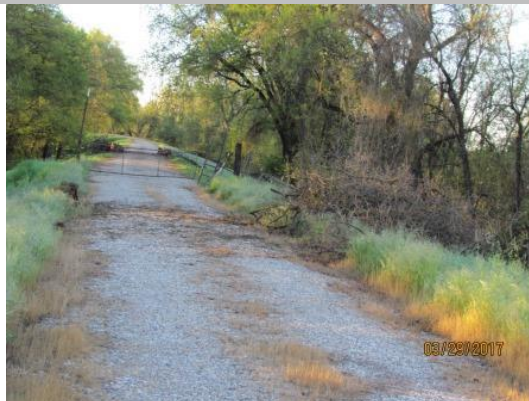
Photo 1 of 1 : SP\_2017\_RD1001\_38\_3\_20170403\_00068.jpg

LM Start	0.14	Rating **	M	Issue No.	3
LM End	0.14	Issue Type +	Ma	Location *	WS
Category	Earthen Levee			GPS Latitude/Longitude	
				Start	End
Item	Encroachments			38.939029 °	38.939029 °
				-121.567771 °	-121.567771 °
DWR ID	DWR_RD1001_04_s_2017_3				
Comment Code					
PR : Prunings					
Inspector Comment					
Remove pruning's from hinge point, Spring 2017.

View looking downstream of pruning's on hinge point, Spring 2017.

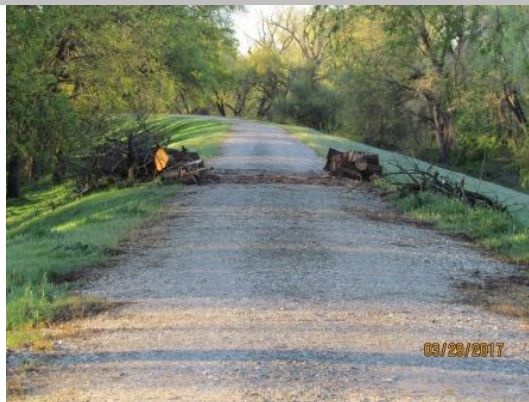
Photo 1 of 1 : SP\_2017\_RD1001\_38\_42\_20170403\_00069.jpg

LM Start	0.20	Rating **	M	Issue No.	42
LM End	0.20	Issue Type +	Ma	Location *	CR
Category	Earthen Levee			GPS Latitude/Longitude	
				Start	End
Item	Encroachments			38.938233 °	38.938233 °
				-121.567731 °	-121.567731 °
DWR ID	DWR_RD1001_04_s_2017_42				
Comment Code					
PR : Prunings					
Inspector Comment					
Remove pruning's from fallen tree from both sides of hinge points, Spring 2017.

view looking downstream of pruning's from fallen tree on both sides of hinge points, Spring 2017.

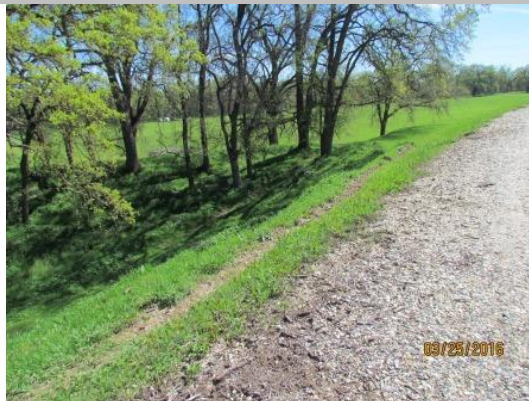
Photo 1 of 3 : SP\_2017\_RD1001\_38\_64\_20170316\_00037.jpg

Livestock trail cut into landside slope. Spring 2016.

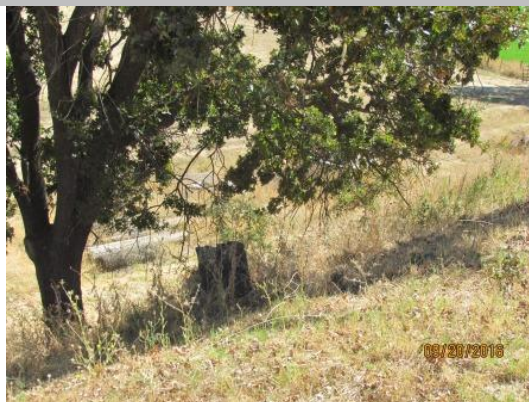
Photo 1 of 1 : SP\_2017\_RD1001\_38\_21\_20170316\_00013.jpg

LM Start	0.51	Rating **	N	Issue No.	21
LM End	0.51	Issue Type +	Ma	Location *	LS
Category	Earthen Levee			GPS Latitude/Longitude	
				Start	End
Item	Trim / Thin Trees			38.933796 °	38.933796 °
				-121.567047 °	-121.567047 °
DWR ID	DWR_RD1001_04_f_2015_21				
Comment Code					
T5 : Tree stumps.					
Inspector Comment					
Remove stump from the landside levee slope.

View of a stump in the landside levee slope. Fall 2016.

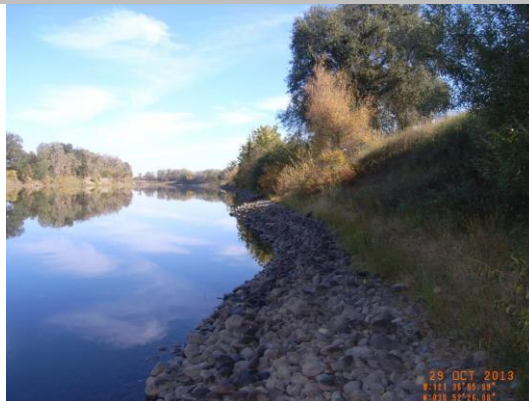
Photo 1 of 1 : SP\_2017\_RD1001\_38\_2\_20170316\_00002.jpg

LM Start	5.80	Rating **	M	Issue No.	2
LM End	5.93	Issue Type +	Ma	Location *	WS
Category	Supplemental			GPS Latitude/Longitude	
				Start	End
Item	2015 USACE Erosion Survey, DRAFT			38.874113 °	38.872373 °
				-121.615380 °	-121.616504 °
DWR ID	DWR_RD1001_04_s_2016_2				
Comment Code					
Inspector Comment					
2011 - Erosion pockets from tree popouts. Sections of the lower bank have slumped off. 2013 - Scallops from tree popouts no longer visible on site. Minor new erosion at the middle of the bank. 2015: Fresh erosion from human use. [2015 Site ID: FHR_6-6_L]

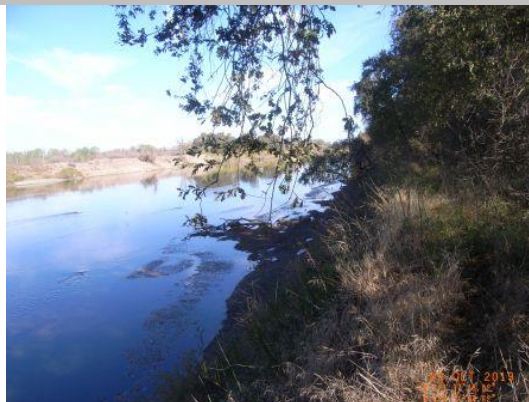
Photo 1 of 1 : SP\_2017\_RD1001\_38\_5\_20170316\_00005.jpg

LM Start	6.42	Rating **	M	Issue No.	5
LM End	6.51	Issue Type +	Ma	Location *	WS
Category	Supplemental			GPS Latitude/Longitude	
				Start	End
Item	2015 USACE Erosion Survey, DRAFT			38.865875 °	38.864706 °
				-121.619983 °	-121.620813 °
DWR ID	DWR_RD1001_04_s_2016_5				
Comment Code					
Inspector Comment					
2011 - Tall slumping sections. Scour around trees has exposed most of the roots. 2015: Recent large slope failure observed. [2015 Site ID: FHR_6-0_L]

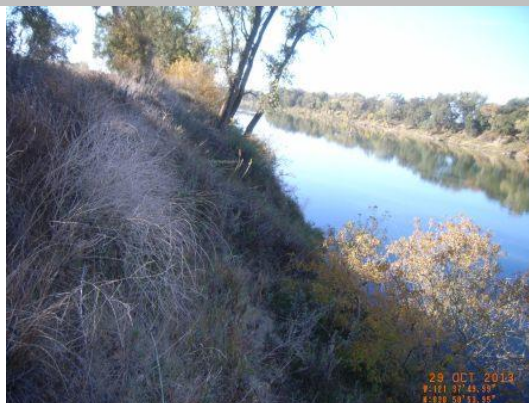
Photo 1 of 1 : SP\_2017\_RD1001\_38\_8\_20170316\_00008.jpg

LM Start	7.47	Rating **	M	Issue No.	8
LM End	7.79	Issue Type +	Ma	Location *	WS
Category	Supplemental			GPS Latitude/Longitude	
				Start	End
Item	2015 USACE Erosion Survey, DRAFT			38.852394 °	38.848004 °
				-121.629231 °	-121.630873 °
DWR ID	DWR_RD1001_04_s_2016_8				
Comment Code					
Inspector Comment					
2000 - Steep bank off berm with some slumps and fallen trees, continued erosion. 2002 - Site lengthened upstream and downstream due to vertical bank along most of the reach. 2010 - Site extended upstream. 2011 - Minimal new erosion. 2012 - Site extended on the upstream end, new tree pop-out, and bank erosion continues to worsen. 2013 - Minor new erosion at the toe and top of bank. 2015: No observed changes. [2015 Site ID: FHR_5-0_L]

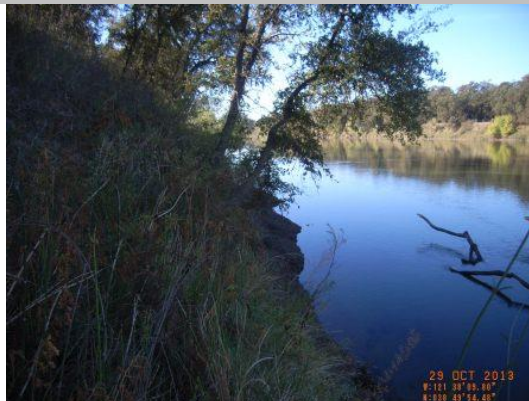
Photo 1 of 1 : SP\_2017\_RD1001\_38\_7\_20170316\_00007.jpg

LM Start	8.57	Rating **	M	Issue No.	7
LM End	8.97	Issue Type +	Ma	Location *	WS
Category	Supplemental			GPS Latitude/Longitude	
				Start	End
Item	2015 USACE Erosion Survey, DRAFT			38.836966 °	38.831498 °
				-121.634128 °	-121.636371 °
DWR ID	DWR_RD1001_04_s_2016_7				
Comment Code					
Inspector Comment					
2006 - Sandy, silty bank with intermittent pockets of erosion. Rotational failure and tree pop outs are most of the problem. Some upper slope fluvial erosion. 2010 - Site extended upstream. The lower Feather may benefit from a regional repair. 2011 - Site combined with 3.6. Minimal new erosion. 2013 - New erosion observed at bank toe. Trees on site now have exposed roots. 2015: No observed changes. [2015 Site ID: FHR_3-8_L]

USACE 2013 Photo #1

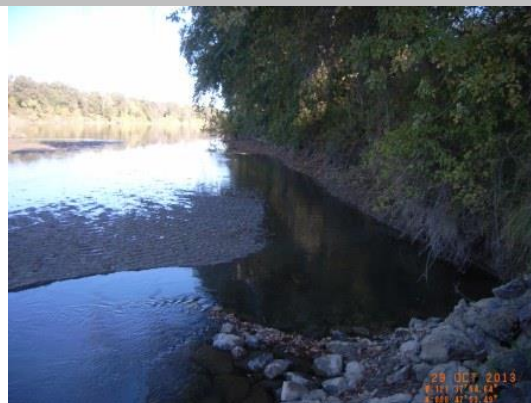
Photo 1 of 1 : SP\_2017\_RD1001\_38\_6\_20170316\_00006.jpg

LM Start	11.18	Rating **	M	Issue No.	6
LM End	11.37	Issue Type +	Ma	Location *	WS
Category	Supplemental			GPS Latitude/Longitude	
				Start	End
Item	2015 USACE Erosion Survey, DRAFT			38.800920 °	38.798165 °
				-121.633050 °	-121.631939 °
DWR ID	DWR_RD1001_04_s _ 2016_6				
Comment Code					
Inspector Comment					
2000 - Site is relatively stable except for some toe erosion at the upstream end, recommend monitoring the upstream end. 2004 - Some new block failures (10ft deep) at the toe of the upstream end. 2007 - Some minor new slumping at the waterline. 2013 - Minor new erosion along the bank toe. 2015: No observed changes. [2015 Site ID: FHR_1-0_L]

USACE 2013 Photo #1

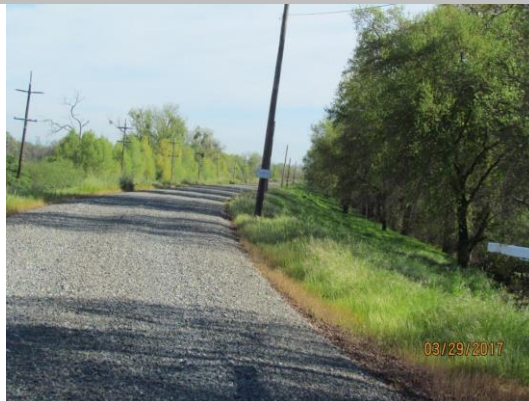
Photo 1 of 1 : SP\_2017\_RD1001\_39\_9\_20170403\_00019.jpg

LM Start	0.01	Rating **	M	Issue No.	9
LM End	5.38	Issue Type +	Ma	Location *	WS
Category	Earthen Levee			GPS Latitude/Longitude	
				Start	End
Item	Vegetation			38.781287 °	38.831062 °
				-121.605442 °	-121.529847 °
DWR ID	DWR_RD1001_05_s_2017_9				
Comment Code					
V1 : Control annual grass and weeds on the levee slopes and easements.					
Inspector Comment					
Maintain annual vegetation, Spring 2017.

View looking upstream of annual vegetation, Spring 2017.

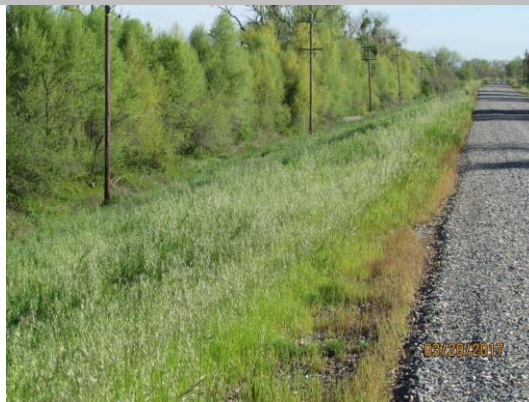
Photo 1 of 1 : SP\_2017\_RD1001\_39\_8\_20170403\_00020.jpg

LM Start	0.01	Rating **	M	Issue No.	8
LM End	5.38	Issue Type +	Ma	Location *	LS
Category	Earthen Levee			GPS Latitude/Longitude	
				Start	End
Item	Vegetation			38.781287 °	38.831062 °
				-121.605440 °	-121.529847 °
DWR ID	DWR_RD1001_05_s_2017_8				
Comment Code					
V1 : Control annual grass and weeds on the levee slopes and easements.					
Inspector Comment					
Maintain annual vegetation, Spring 2017.

View looking upstream of annual vegetation, Spring 2017.

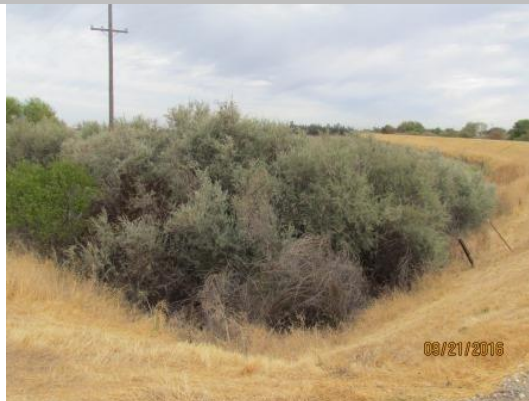
Photo 1 of 2 : SP\_2017\_RD1001\_40\_18\_20170316\_00004.jpg

LM Start	0.01	Rating **	U	Issue No.	18
LM End	0.01	Issue Type +	Ma	Location *	LS
Category	Earthen Levee			GPS Latitude/Longitude	
				Start	End
Item	Trim / Thin Trees			38.831192 °	38.831192 °
				-121.529580 °	-121.529580 °
DWR ID	DWR_RD1001_06_s_2016_18				
Comment Code					
T3 : Trim and thin trees to allow visibility of the ground and room to flood fight.					
Inspector Comment

View of trees that need to be trimmed for visibility on the landside looking upstream. Fall 2016.

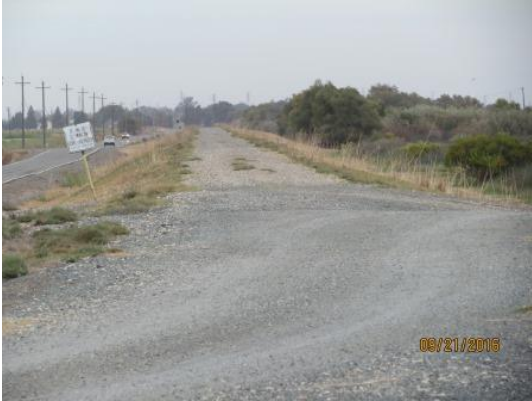
Photo 1 of 1 : SP\_2017\_RD1001\_40\_8\_20170316\_00003.jpg

View of crown where there is cross traffic looking upstream. Monitor this area and fix as needed.

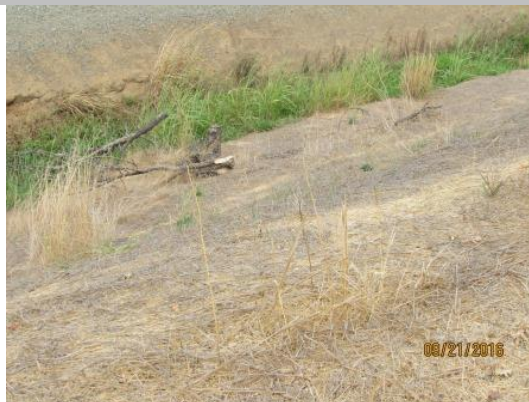
Photo 1 of 1 : SP\_2017\_RD1001\_40\_22\_20170316\_00007.jpg

LM Start	4.38	Rating **	N	Issue No.	22
LM End	4.38	Issue Type +	Ma	Location *	LS
Category	Earthen Levee			GPS Latitude/Longitude	
				Start	End
Item	Trim / Thin Trees			38.893728 °	38.893728 °
				-121.524715 °	-121.524715 °
DWR ID	DWR_RD1001_06_f_2016_22				
Comment Code					
T5 : Tree stumps.					
Inspector Comment					
A stump at the landside levee toe.

View of a stump at the landside levee toe. Fall 2016.
